DEPARTMENT OF TRANSPORTATION**DIVISION OF ENGINEERING SERVICES**

Contract #: 04-0120F4Cty: SF/ALA Rte: 80 PM: 13.2/13.9File #: 69.28**WELDING INSPECTION REPORT****Resident Engineer:**Pursell, Gary**Address:** 333 Burma Road**City:** Oakland, CA 94607**Report No:** WIR-003378**Date Inspected:** 26-Jul-2008**Project Name:** SAS Superstructure**OSM Arrival Time:** 630**Prime Contractor:** American Bridge/Fluor Enterprises, a JV**OSM Departure Time:** 1530**Contractor:** Zhenhua Port Machinery Company, Ltd (ZPMC), Changxing Island **Location:** Shanghai, China

On this date, Caltrans Office of Structural Material (OSM) Quality Assurance (QA) Inspector Joselito Lizardo was present as requested to perform observations on the fabrication of Orthotropic Box Girder (OBG) and SAS Tower at Zhenhua Port Machinery Company (ZPMC) facility at Changxing Island, in Shanghai, China.

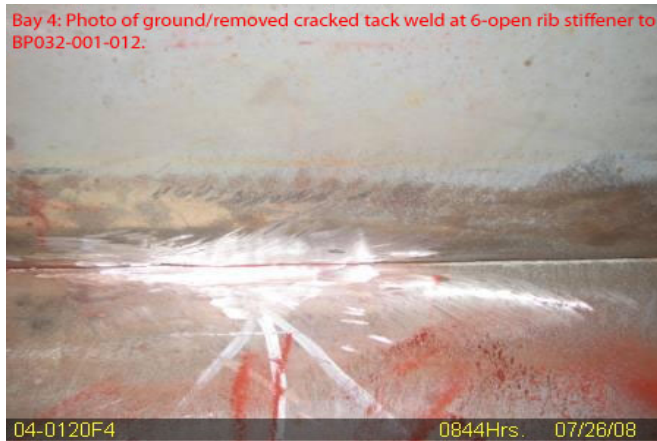
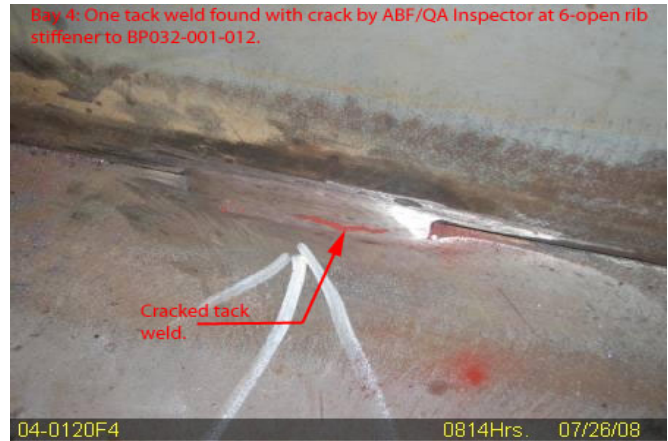
This QA was called by ZPMC/CWI Inspector and showed one tack weld that has cracked on 6-open rib stiffener to bottom plate BP032-001-012. This crack was confirmed through MT and after confirming, ZPMC removed the affected tack by grinding. After removal, ZPMC had MT'd the tack removal and found deemed acceptable. See photo below.
